1HRHV 1412

**Valve Information:**

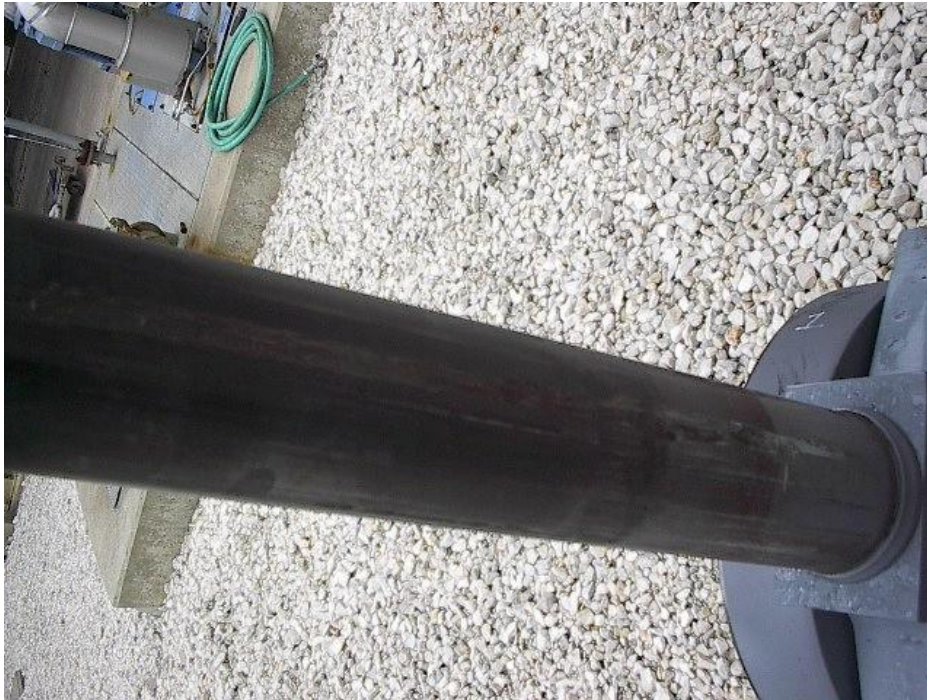
1. Stem had severe galling in packing area which had transferred to the bushing in the breech
2. Stem had to be machined out of the carrier as a result of the threads galling resulting in much more difficult than normal

As found stem showing damage to packing area

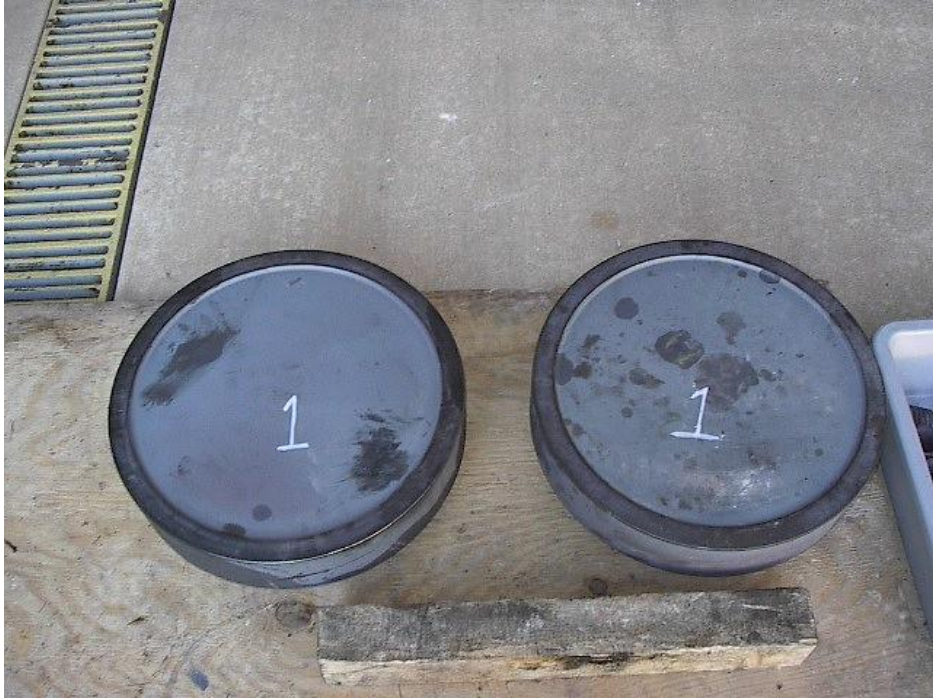
3. Seats were in good shape
4. Discs were in good shape w/ minor scratching
5. Packing area was in good shape

As found discs

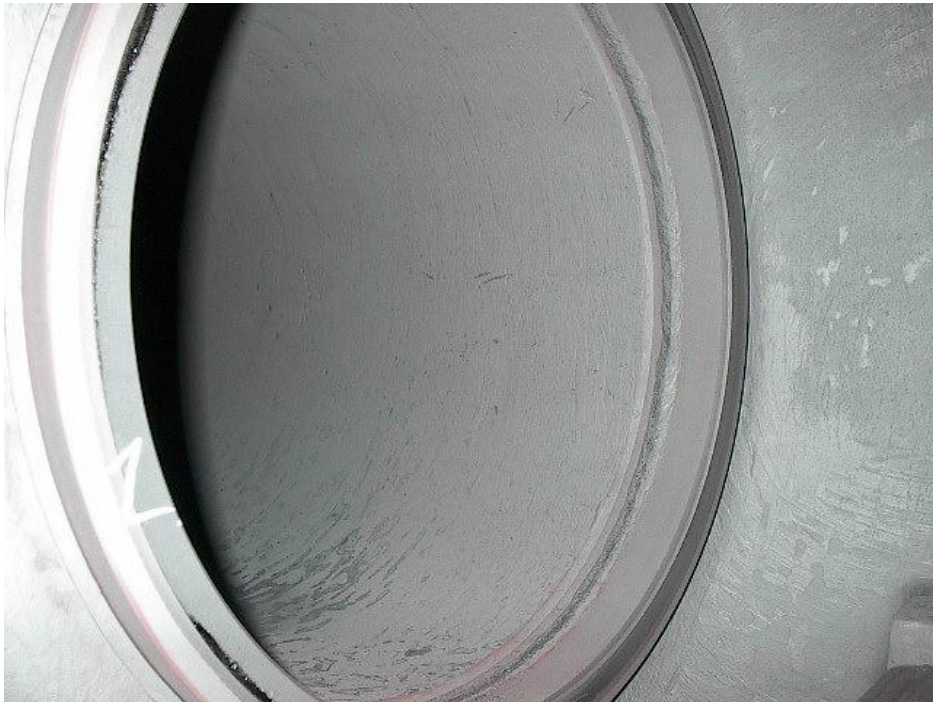
As found seat

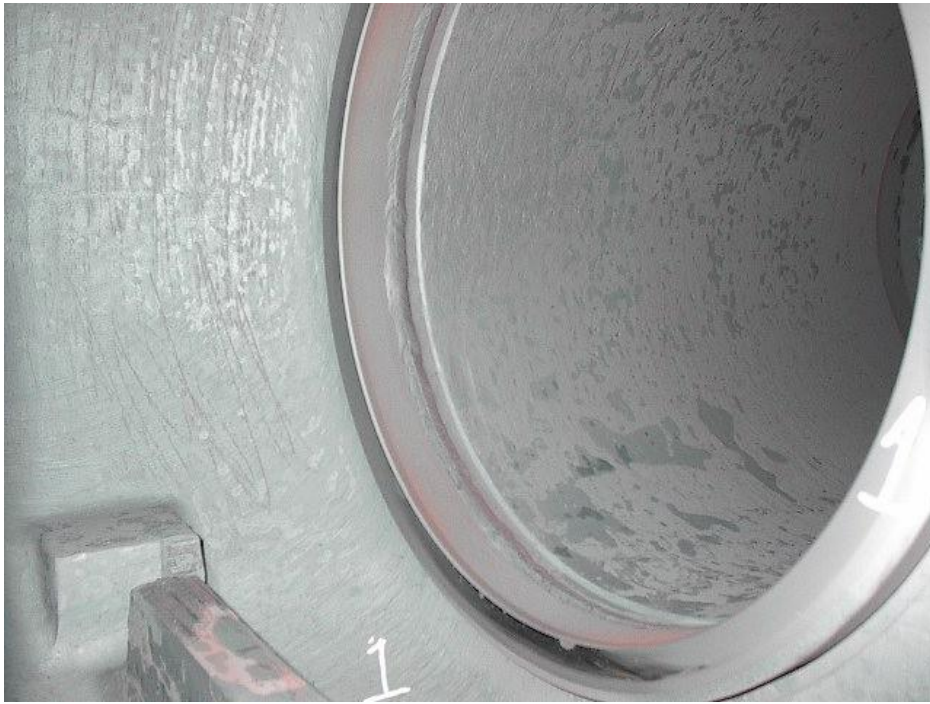
Second as found seat

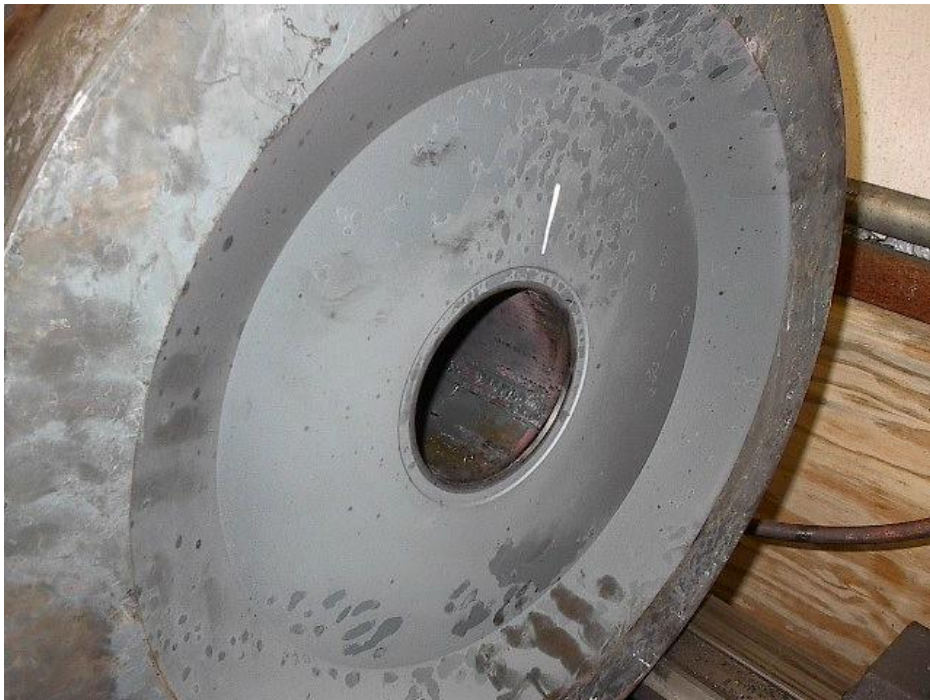
Backseat/breech ID before machining showing galling from stem

1. Lap/polish seats
2. Skim cut & polish discs
3. Install new stem
4. Install new elevating nut in actuator
5. Skim cut breech seal ring area.
6. A clean up cut was made in the ID of the breech & back seat where the stem rides to allow for more clearance to prevent future galling. A carbon spacer was installed as well to help support the stem and take up extra space in the packing box
7. A new pressure seal was made
8. Install 5 ring packing set
9. Assemble

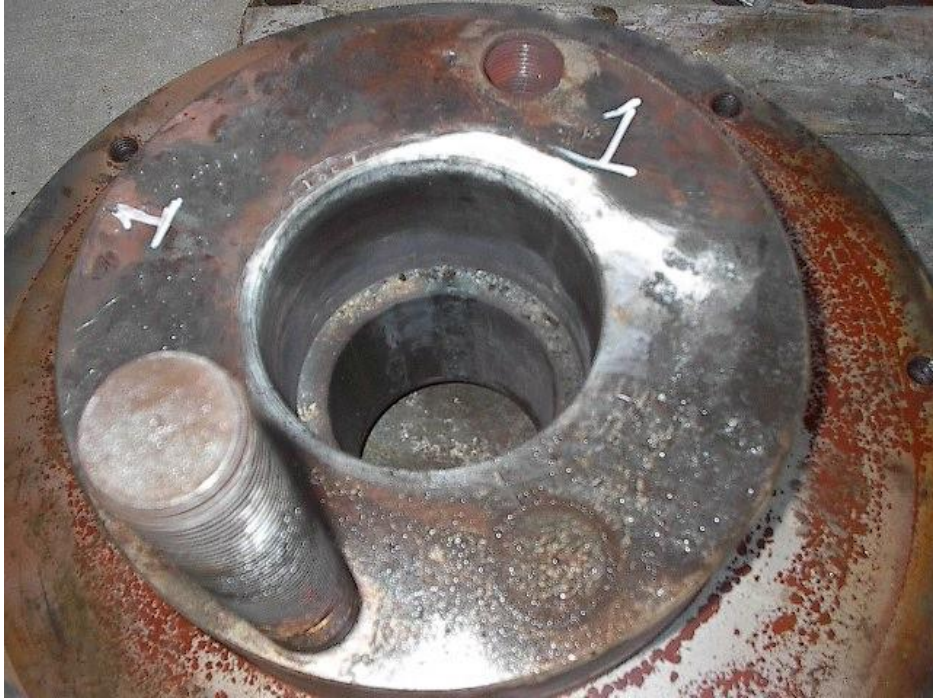
Breech packing area

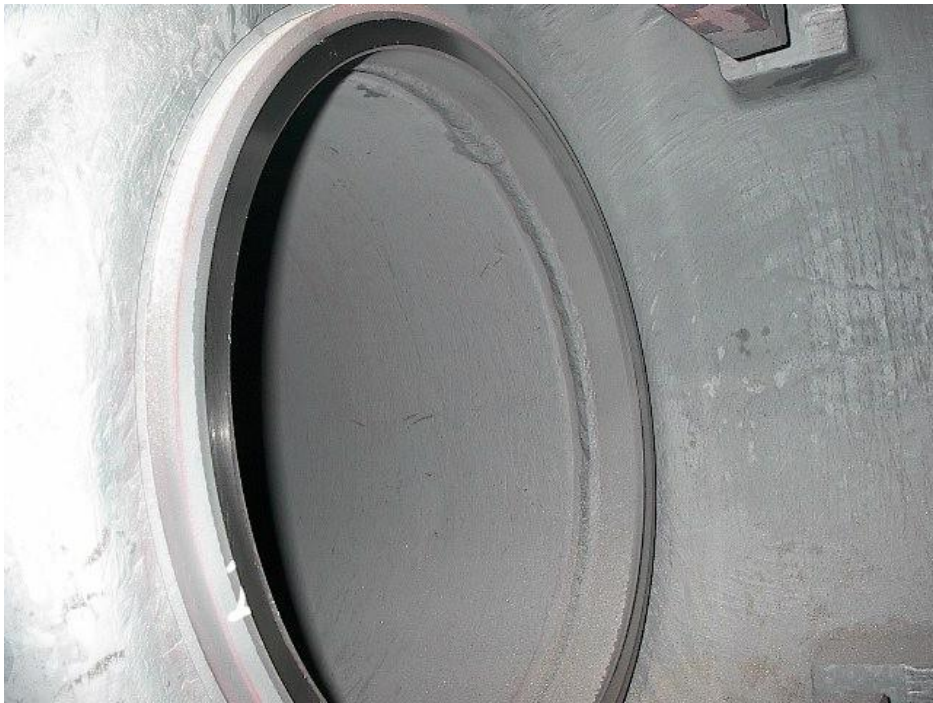
Seat after lapping/polishing

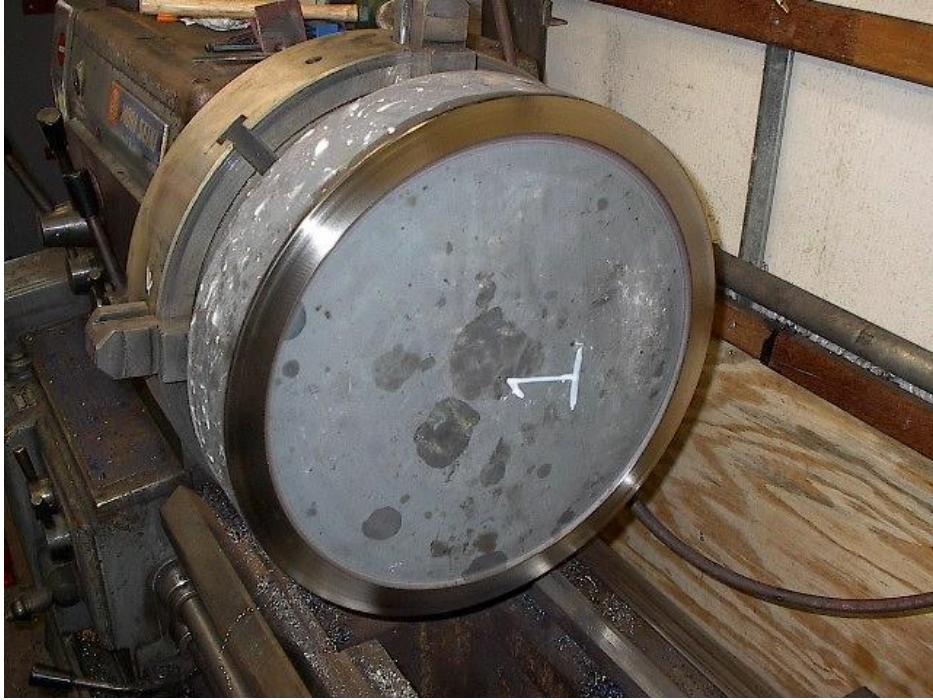
Disc after skim cut/polish

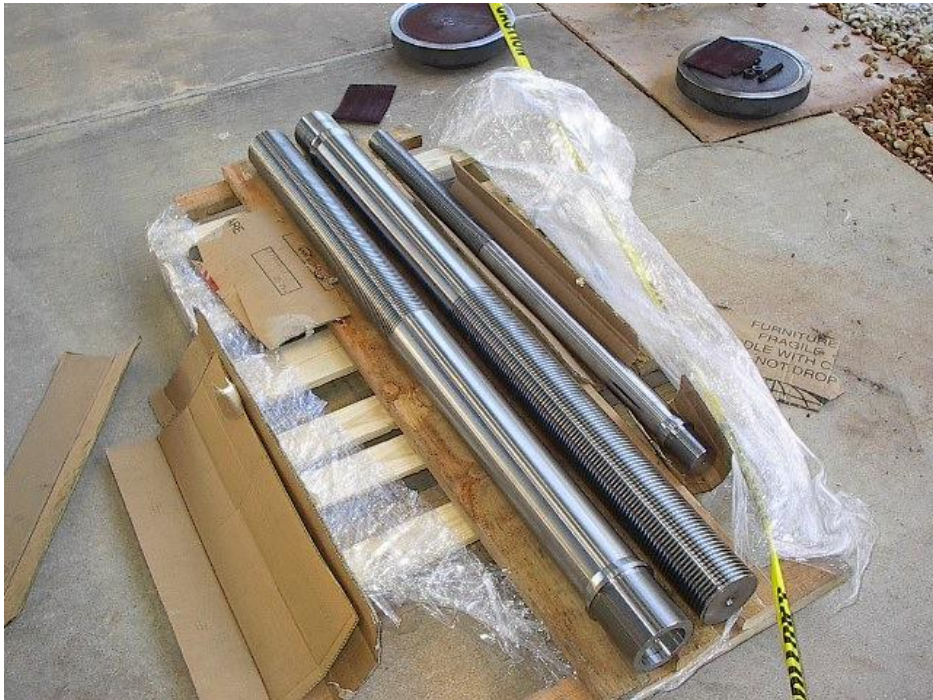
New stems

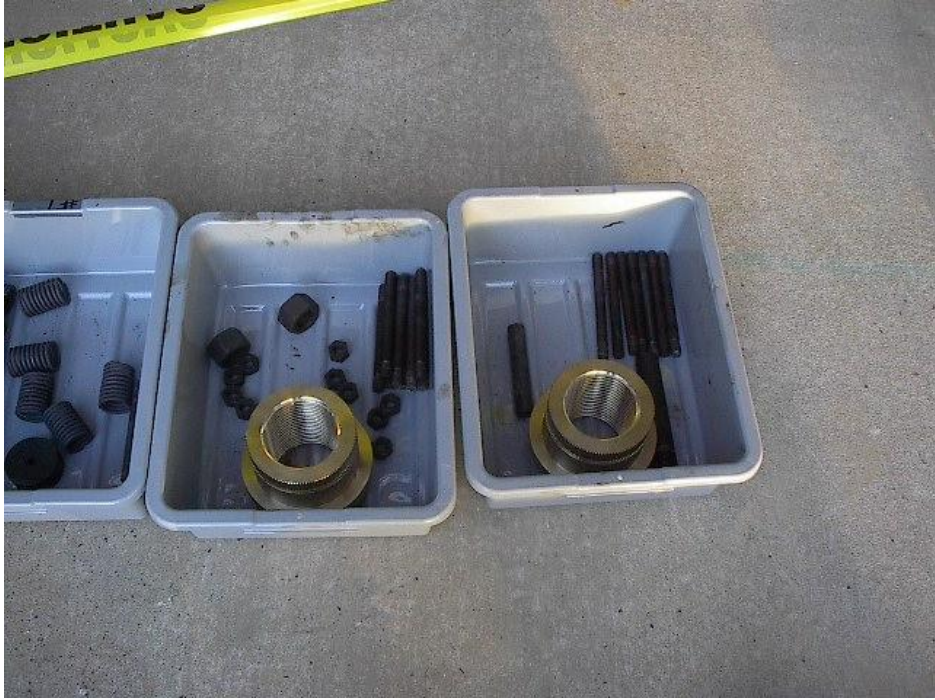
New elevating nuts and studs

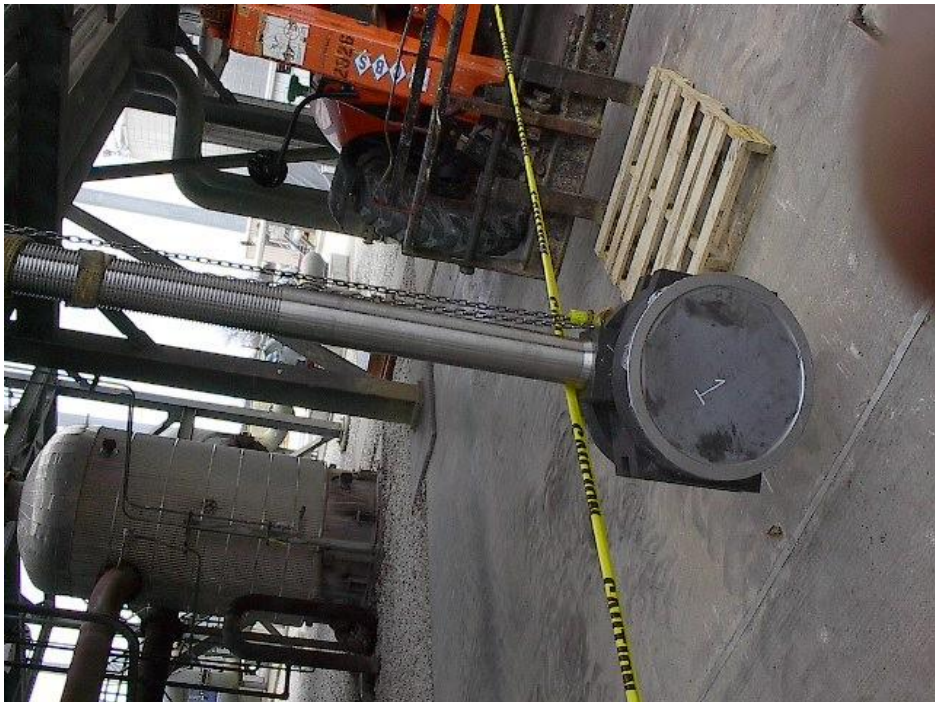
Stem and discs ready for assembly
